### RCRA COMPLIANCE INSPECTION REPORT

Facility: Cherokee Station

Inspection Type: Compliance Evaluation Inspection

Date: September 26, 1997

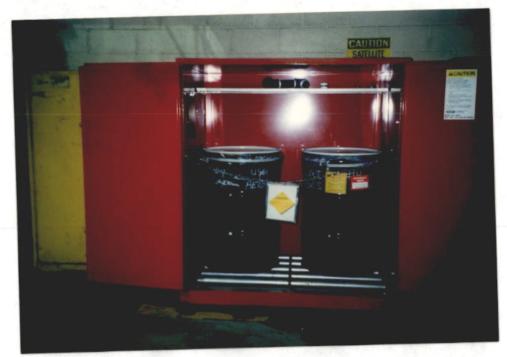
At the first satellite accumulation area, the Laydown Area, there were two Flammable Cabinets. The first Flammable Cabinet contained 2 drums: 1 Used Aerosol Cans (on drum) and one drum with a Hazardous Waste (label) "Solvent Debris". The second Flammable Cabinet contained the following drums: one drum with a Hazardous Waste label, "Used/Waste Solvent" and one drum, "Waste Paint" with a Hazardous Waste label. Outside the Flammable Cabinets, there were drums being stored on pallets consisting of the following:

Photo 1: Laydown Satellite Accumulation Area Flammable Cabinet 1

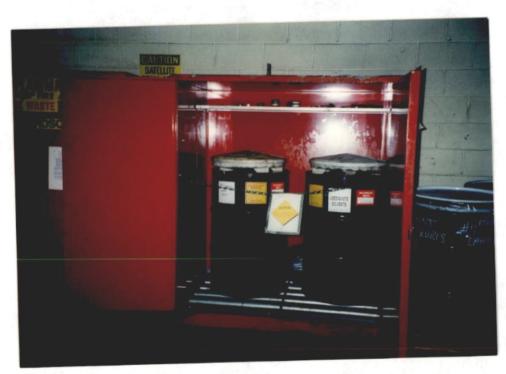
Photo 2: Laydown Satellite Accumulation Area Flammable Cabinet 2

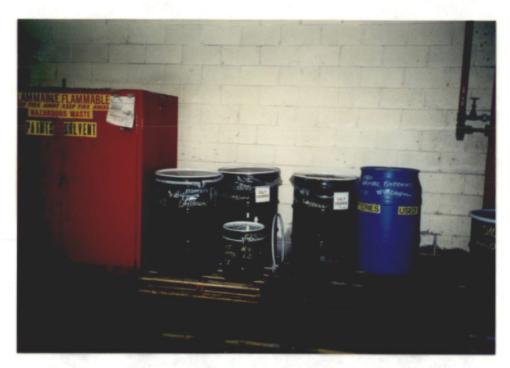
- 1 Paint Debris only (black 55-gal)
- 2 Oily Debris (black 55-gal)
- 1 light ballasts only, approx. 10 gal.
- 1 blue, 55-gal plastic, used batteries

The above, for which they have waste profiles, are managed as industrial wastes and shipped to CSI.

Photo 3: Drums on Pallets at Laydown Satellite Accumulation Area

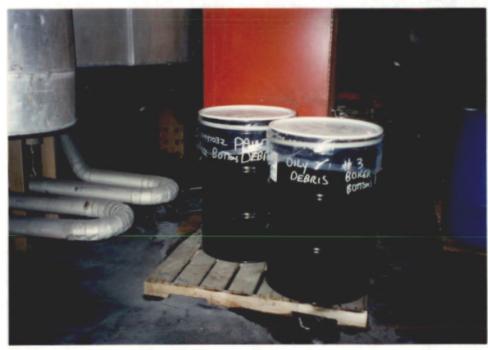
We then looked at the second satellite accumulation area, the No. 3 Boiler Bottom. There were 2 drums on a pallet, labeled as "Oily Debris" and "Paint Debris". Both were 55-gallon black steel, non-hazardous drums. If it is suspected that lead paint will be encountered during maintenance, Cherokee Station sets up a special drum for lead debris or abatement.

Photo 4: No. 3 Boiler Bottom Satellite Accumulation Area 2 Drums on Pallet

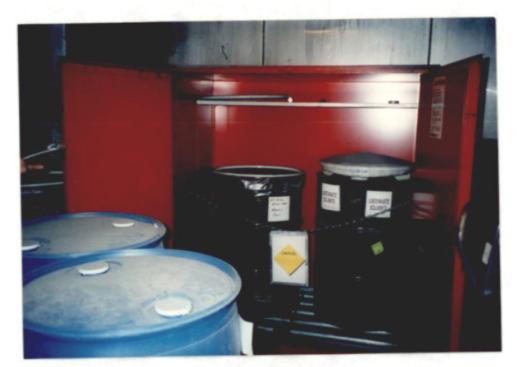
The Flammable Cabinet at the No. 3 Boiler Bottom satellite accumulation area contained 2 black 55-gallon drums inside, labeled as "Used/Waste Solvent" (liquid), and "Aerosol Cans".

Photo 5: No. 3 Boiler Bottom Satellite Accumulation Area Inside Flammable Cabinet

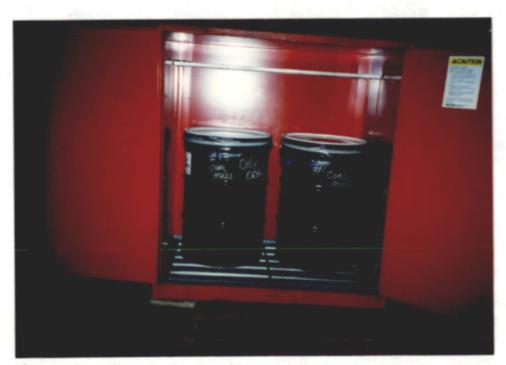
We looked at the third satellite accumulation area, the Number 1 Coal Mill. Inside the Flammable Cabinet were 2 black 55-gal drums, labeled as "Oily Debris" (non-haz.) and "Aerosol Cans (haz). In this area, there was one blue plastic drum on a pallet for dry cell batteries.

Photo 6: No. 1 Coal Mill Satellite Accumulation Area Inside Flammable Cabinet

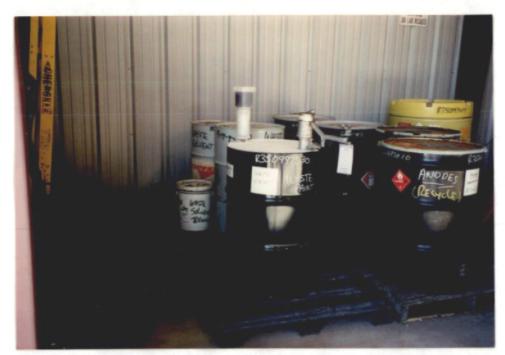
Inside the Hazardous Waste Storage Area is an aerosol puncture drum labeled "Waste Paint", with a Hazardous Waste Label. The other wastes stored in this area included the following:

Photo 7: Drums of Waste in Hazardous Waste Accumulation Area

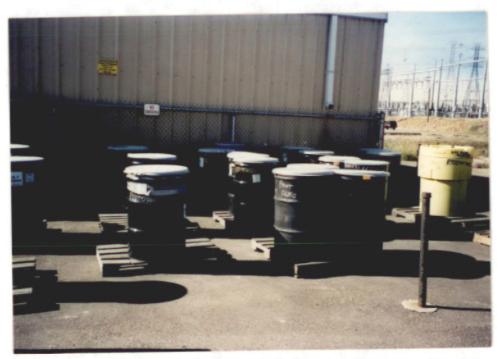
There were numerous drums of industrial waste, stored outside Hazardous Waste Accumulation Area. These have been characterized as non-hazardous and are disposed at CSI, including batteries. Shipments/waste profiles are handled by PSC. Environmental Services (central office downtown). The Industrial Waste Storage includes:

Photo 8: Part of Industrial Waste Storage Drums Beside Hazardous Waste Accumulation Area

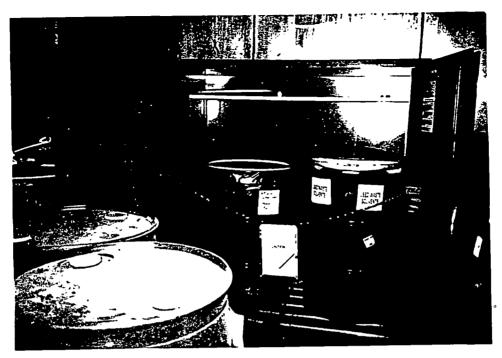
The Flammable Cabinet at the No. 3 Boiler Bottom satellite accumulation area contained 2 black 55-gallon drums inside, labeled as "Used/Waste Solvent" (liquid), and "Aerosol Cans".

Photo 5: No. 3 Boiler Bottom Satellite Accumulation Area Inside Flammable Cabinet

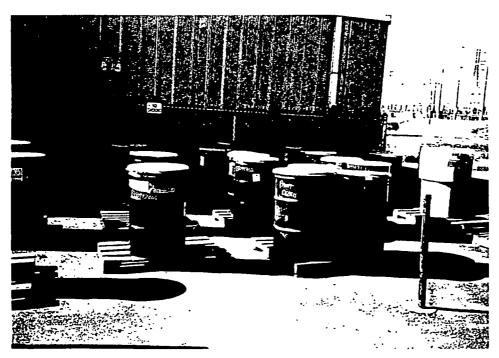
There were numerous drums of industrial waste, stored outside Hazardous Waste Accumulation Area. These have been characterized as non-hazardous and are disposed at CSI, including batteries. Shipments/waste profiles are handled by PSC Environmental Services (central office downtown). The Industrial Waste Storage includes:

Photo 8: Part of Industrial Waste Storage Drums Beside Hazardous Waste Accumulation Area
